Food & Beverage Plant inspection

**RE: Boiler no 1 inspected 16/11/12**

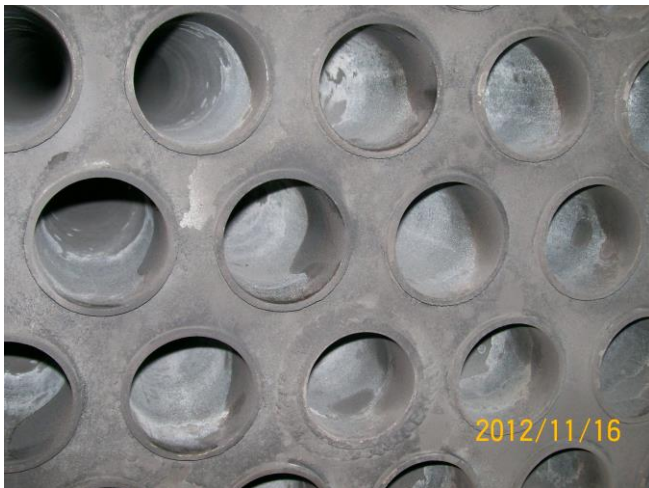
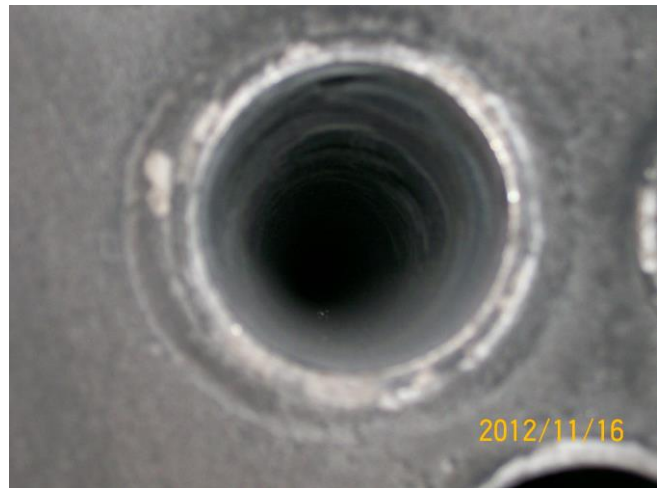
**Boiler No 1 Front plate with Sapec treatment**

The tubes are in excellent condition, very light scale in places. Minimum reduction in Heat transfer rates

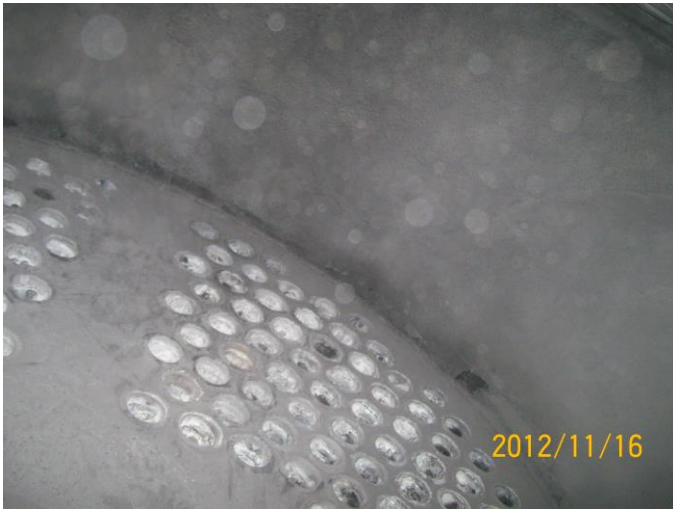
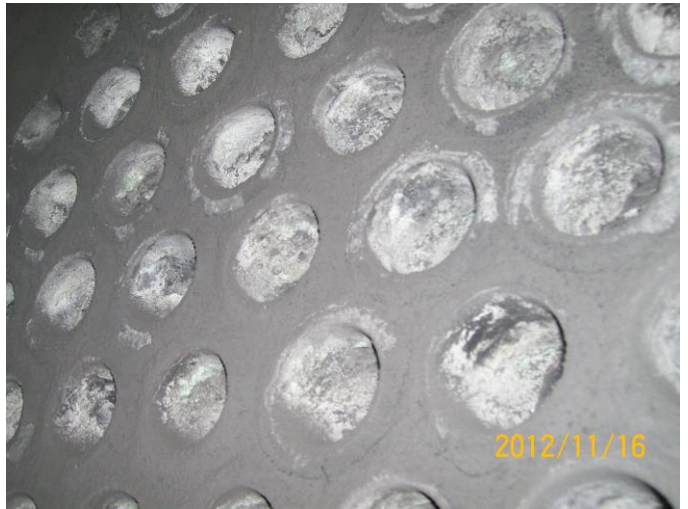
**BOILER NO 1- REVERSAL CHAMBER**

There is some evidence of build up, however these are soft and easily removed through compressed air. There is no birds-nesting. It is clear that since the introduction of the SAPEC treatment the soot blowers are more effective and that the heat transfer rates are being maintained throughout the operating period. The huge difference in the condition of boiler 1 since the introduction of the SAPEC system can be seen by the next section of the report that shows Boiler 1 in 2010 without the use of SAPEC

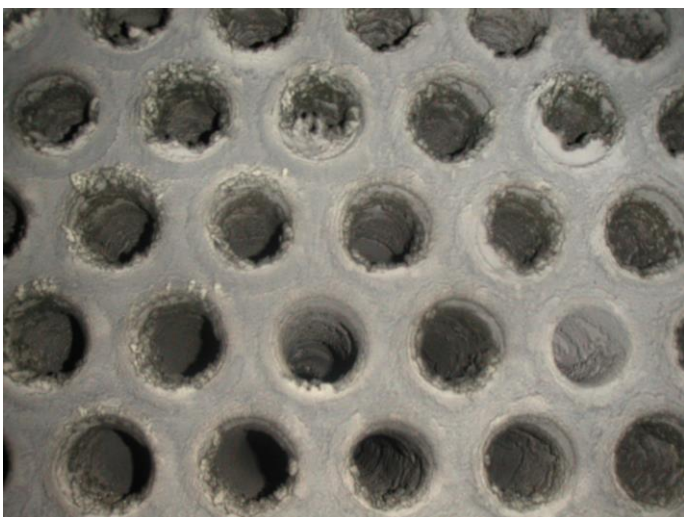
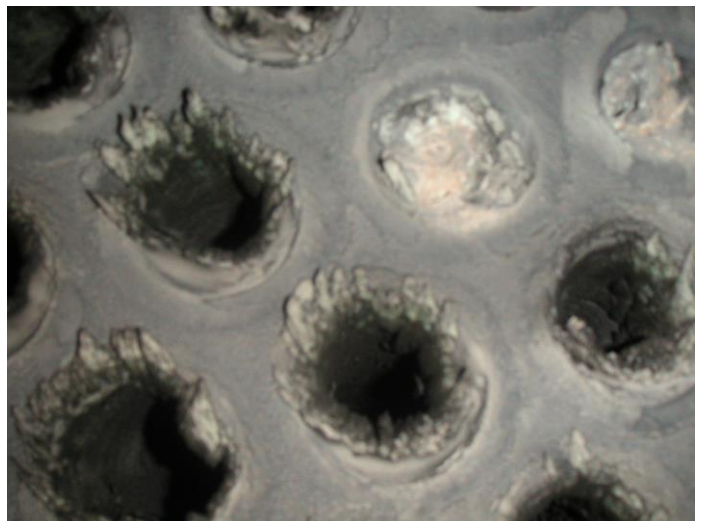
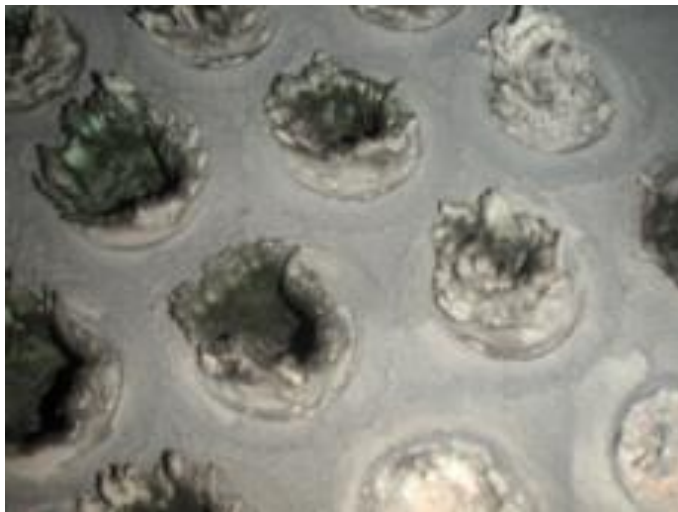
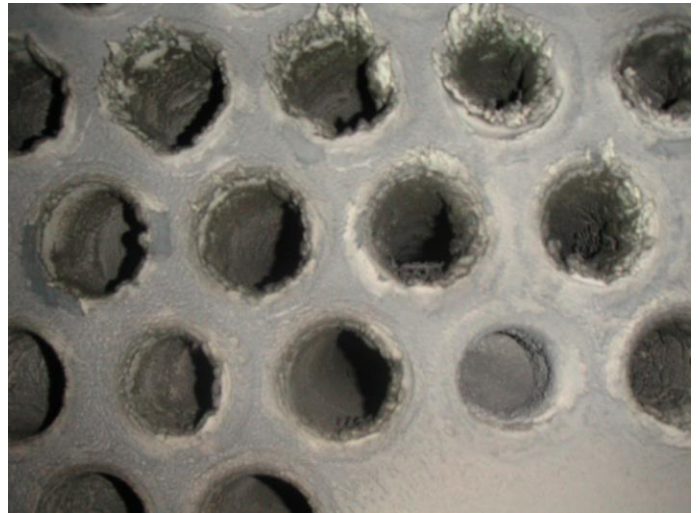
#### **Boiler No 1 in 2010 with no Sapec treatment after 3 months operation**

The tubes are in a really bad condition. The deposits are solid, bonded to the metal and very difficult to remove. Abrasive de-scaling had to be used to clean the tube. Their must be considerable fuel losses.
