COST BENEFIT ANALYSIS: THE SAPEC SYSTEM

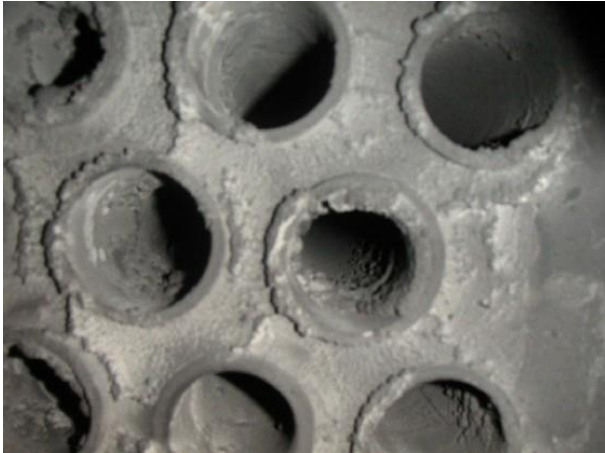
BEFORE SAPEC WAS INTRODUCED

Hard scale up to 4mm thick

SAPEC was introduced on to the boilers at Food & Beverage plant after the plant had experienced fouling problems on the boilers at the site. The fouling which is illustrated below was up to 4mm thick in places and was extremely hard and difficult to remove. Many of the tubes were blocked in the reversal chamber. The plant has now been operating successfully with SAPEC for almost a year and the boiler fouling has been dramatically reduced as is illustrated by the photographs below

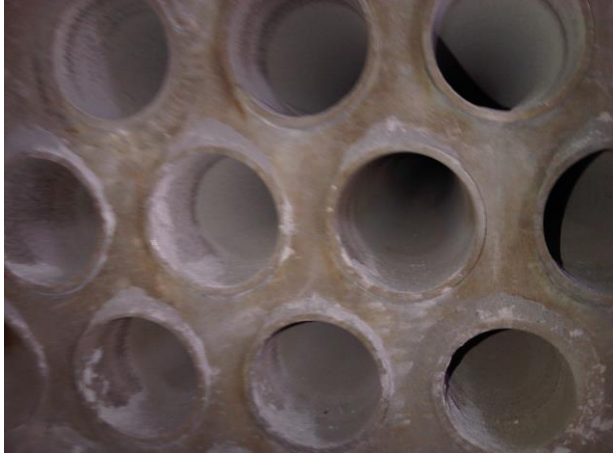
BOILER 2 AFTER 6 MONTHS OPERATION WITH SAPEC 26/02/09

No Hard Scale, just a light dust

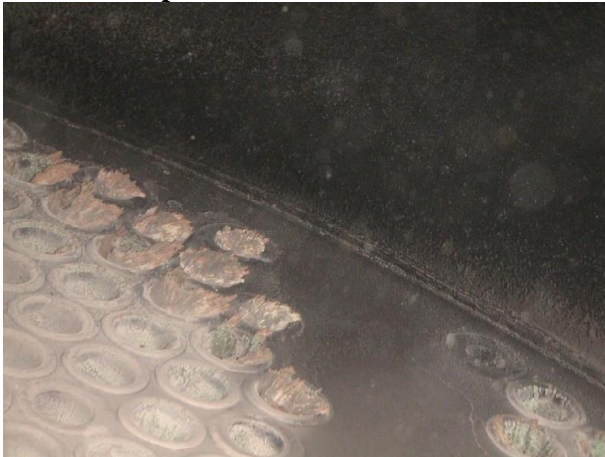
Reversal Chamber No SAPEC

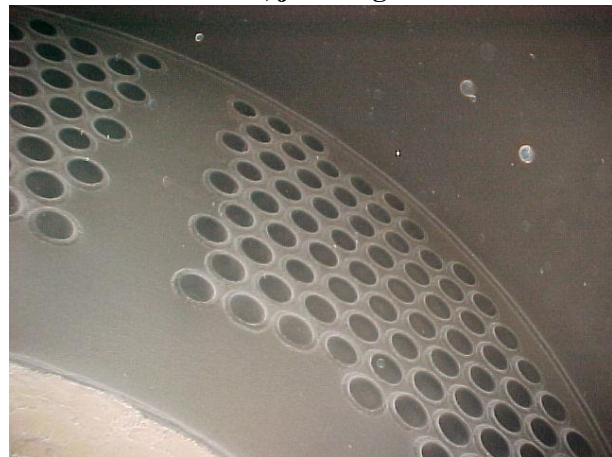
Reversal Chamber with SAPEC
