Food & Beverage Plant inspection

**RE: Boiler no 1 inspected 16/11/12**

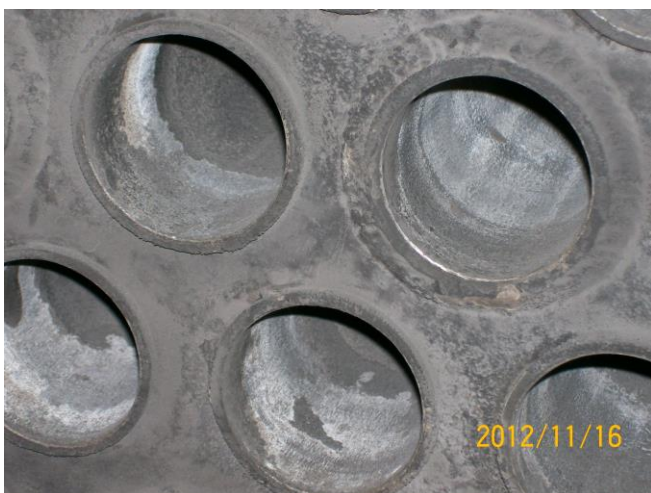
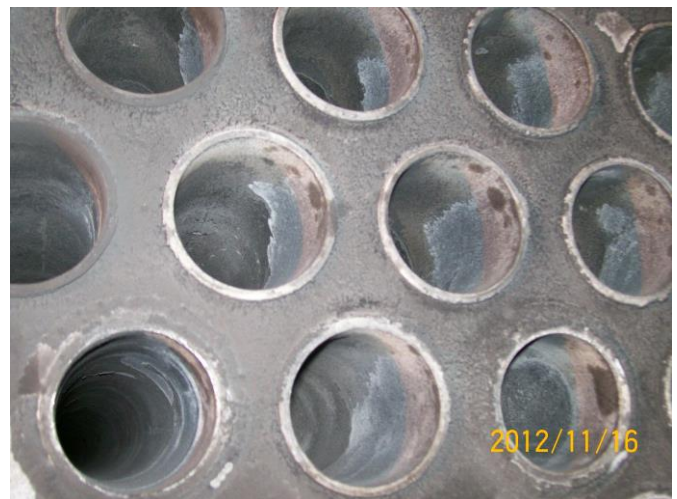
**BOILER NO 1- REVERSAL CHAMBER**

The tubes are in excellent condition, very light scale in places. Minimum reduction in Heat transfer rates

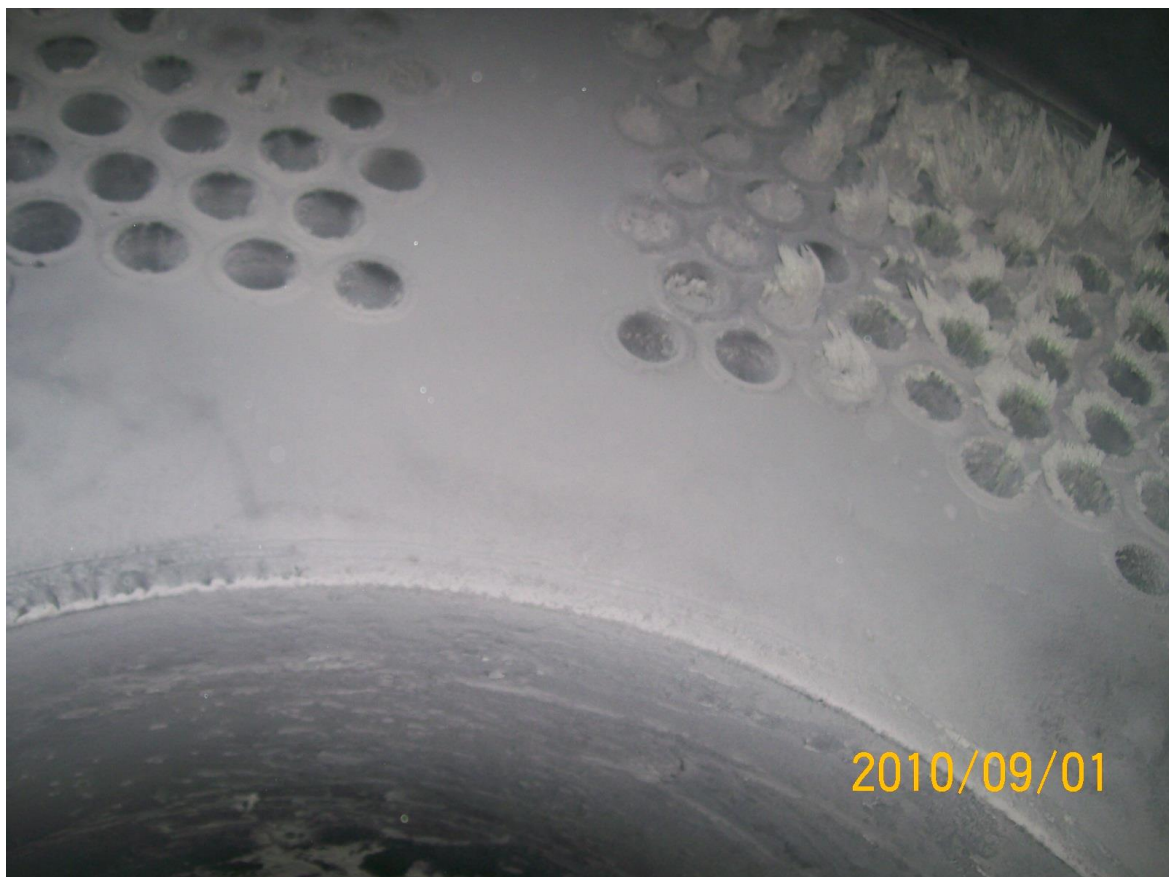
#### **Boiler No 1 in 2010 with no Sapec treatment after 3 months operation**

The tubes are in a really bad condition. The deposits are solid, bonded to the metal and very difficult to remove. Abrasive de-scaling had to be used to clean the tube. Their must be considerable fuel losses.
